Subject: Letter of Completion for 1155 Los Palos Street, Los Angeles, CA 90023  
PIA-05444, 5191004003

## EXECUTIVE SUMMARY

This Letter of Completion (LOC) documents the cleanup activities that were completed at the above referenced property (hereafter, the Property). The Property location and surrounding area are shown on Figure 1.

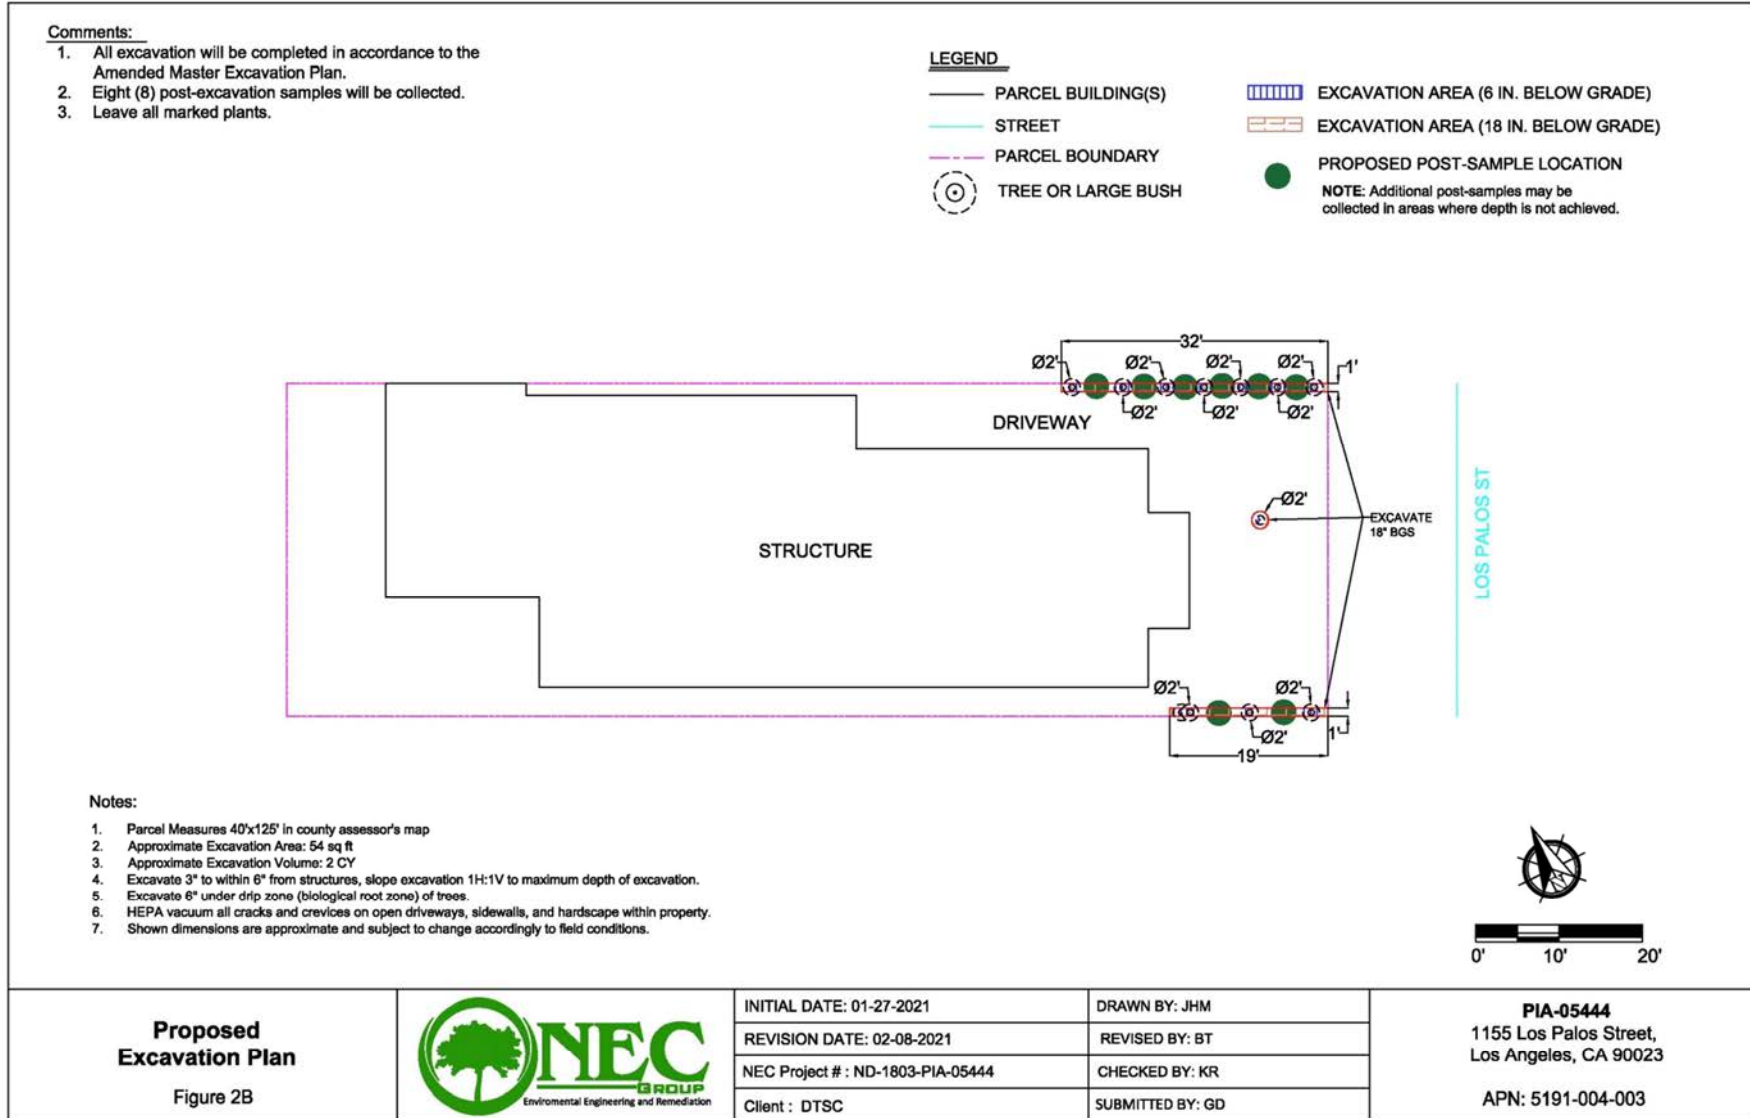
Figure 2B Excavation Plan

**PROPOSED SOIL EXCAVATION AREA AND VOLUME**

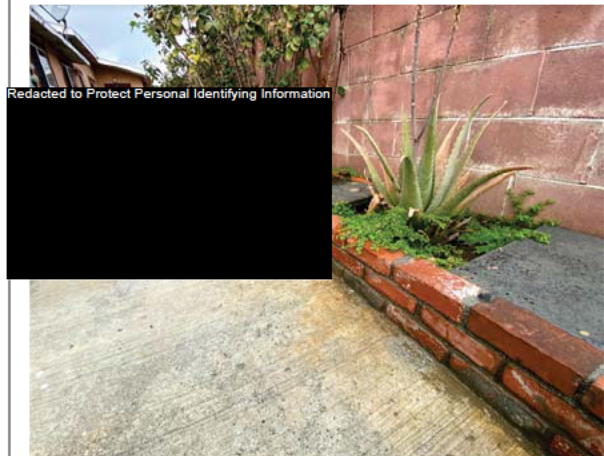
Side Yard Pre-Excavation

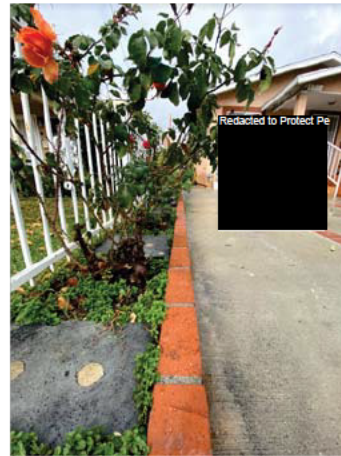
Side Yard Pre-Excavation

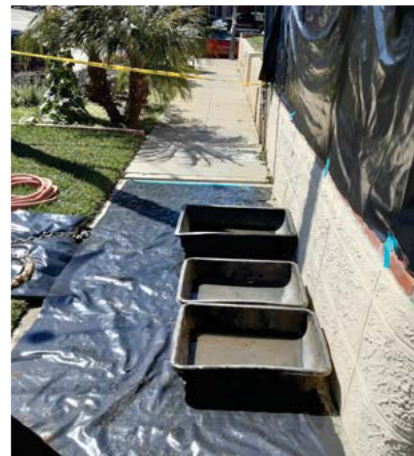
Decontamination Station

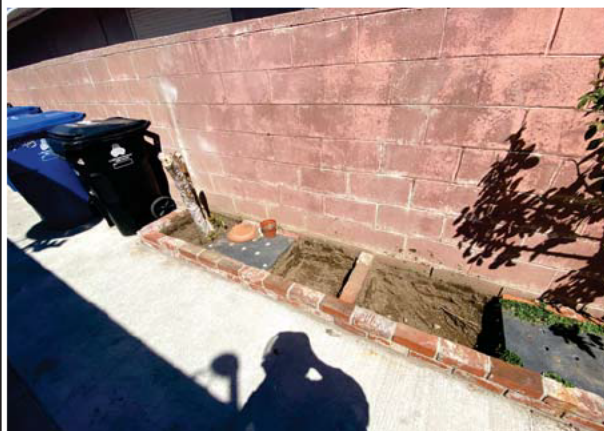
Side Yard Excavation

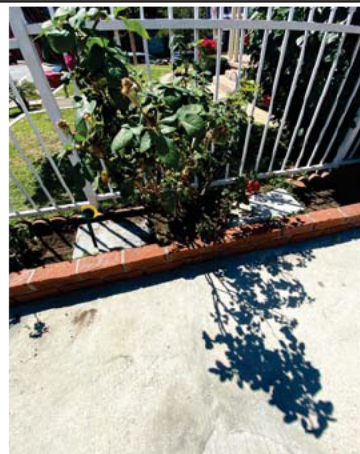
Side Yard Excavation

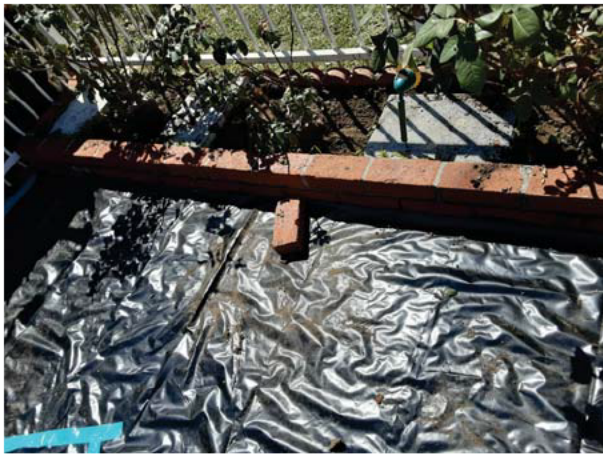
Side Yard Restoration

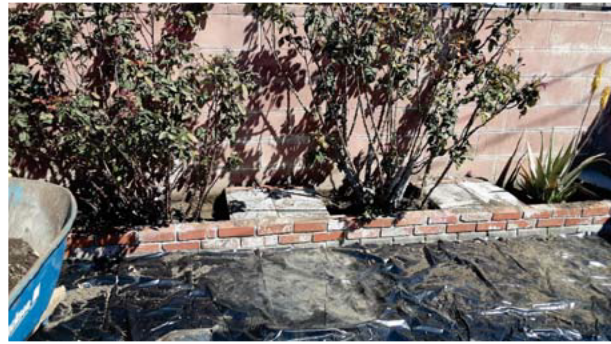
Side Yard Restoration

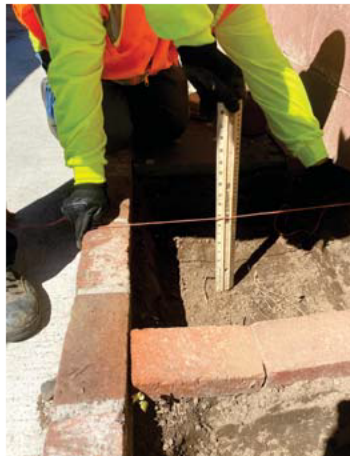
Side Yard Depth Confirmation

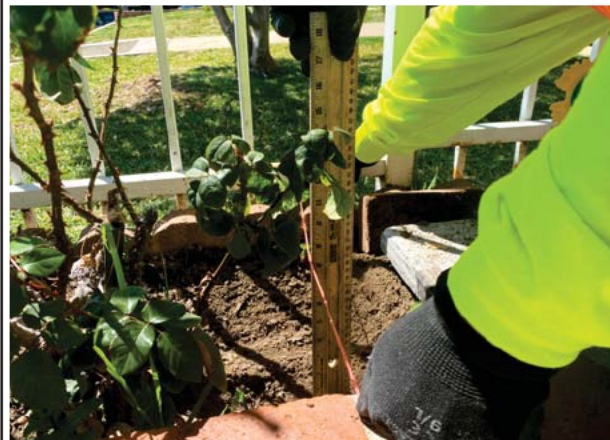
Side Yard Depth Confirmation

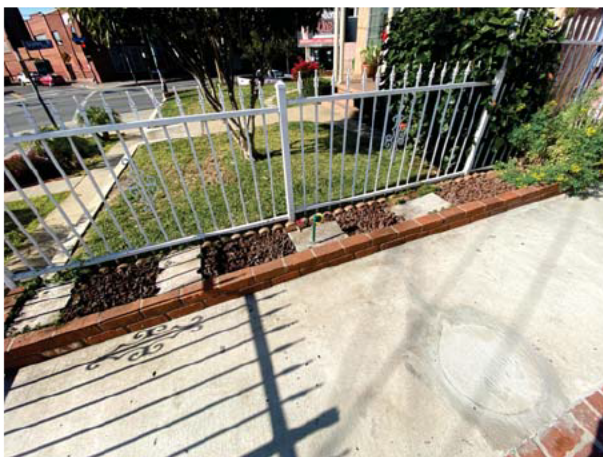
Side Yard Final Restoration

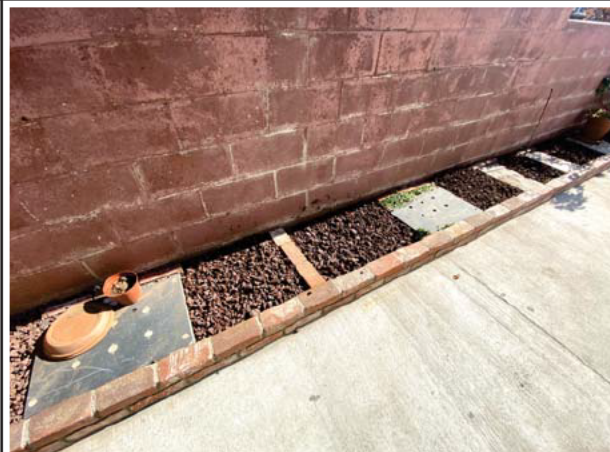
Side Yard Final Restoration
